TECHNICAL REPORT M-70-II

MOBILITY EXERCISE A (MEXA) FIELD TEST PROGRAM

PERFORMANCE OF MEXA AND THREE MILITARY VEHICLES
IN SOFT SOIL

Volume I

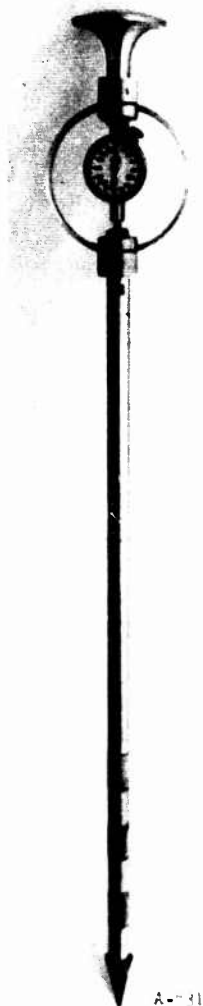
Fig. 1. Cone penetrometer

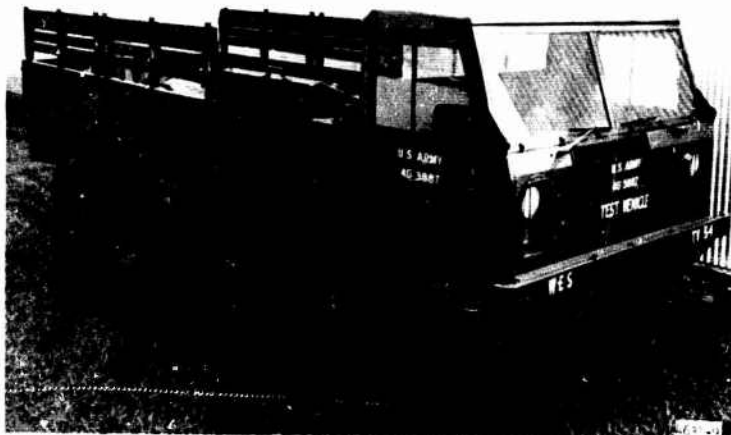
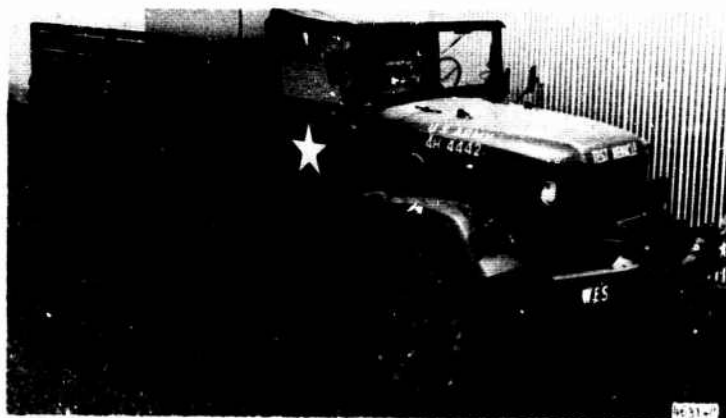
Fig. 5. Military vehicles used in test program

7. The wheeled military vehicles tested were the XM410E1 and the M35A2 (mod) and the tracked vehicle was the M113 (see fig. 5). The MEXA

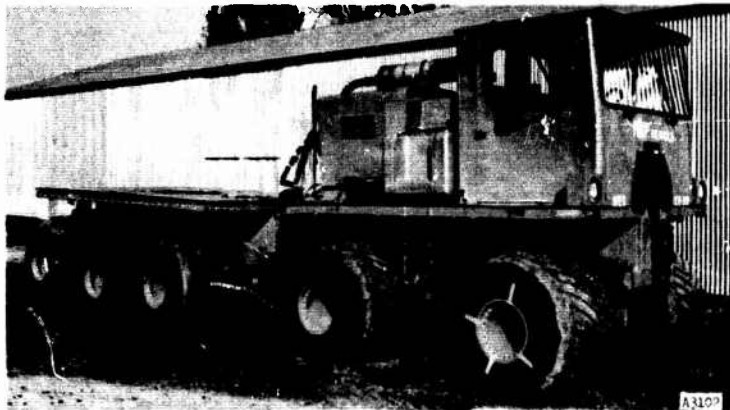
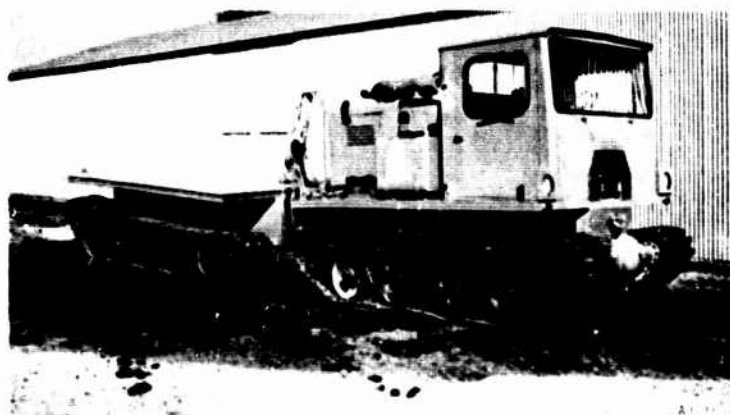
Fig. 6. MEXA vehicles used in test program

vehicles tested were the MEXA 10x10 and MEXA 8x8 (both wheeled) and the MEXA track (see fig. 6). The modifications to the M35A2 consisted of changing the tires to 11:00x20 NDCC and changing from dual rear wheels to single rear wheels. Pertinent data for the six vehicles are given in

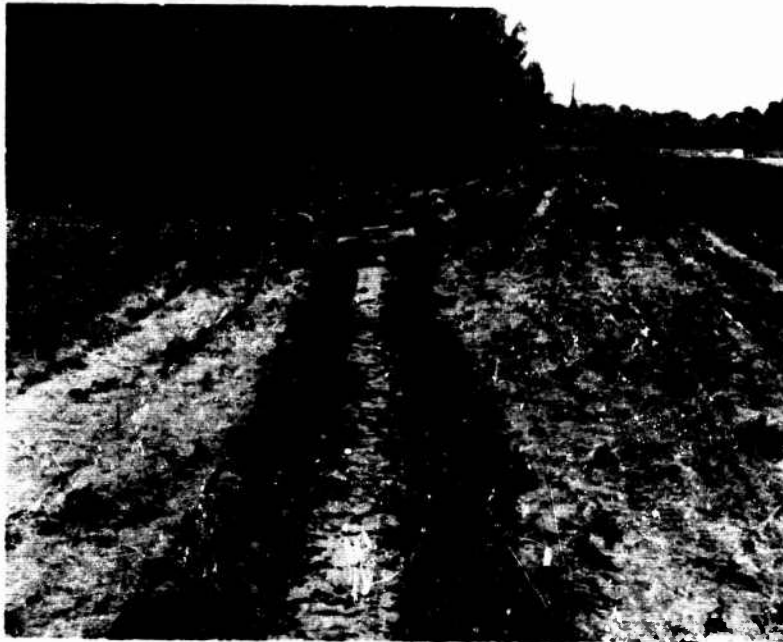
Fig. 8. WES Reservation test site

(B Stream) that flows through the WES Reservation (figs. 7 and 8). The site was a soft, relatively level, recent hydraulic fill that varied from 3 to 6 ft in depth; the material for the fill had been pumped from the nearby WES lake. The fill soil classified as fat clay (CH) in the 0- to 6-in. layer and as lean clay (CL) in the 6- to 18-in. layer according to the USCS (fig. 9). Most of the vegetation (tall weeds) was removed before testing.

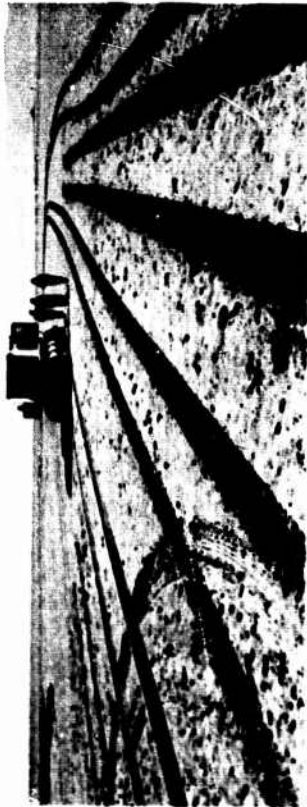
b. Site 3

d. Site 5

a. Site 2

covering about 400 square miles. It is located about 20 miles northeast of Fallon (see fig. 13). Carson Sink serves from time to time as a sump for water diverted from the Carson River to relieve flooding of adjacent farmlands and of nearby Fallon National Wildlife Refuge. At the time of testing, most of the ground at Carson Sink was firm and free of surface water. After a thorough investigation of the playa, four sites (see fig. 14), each having a different soil strength, were established and tested. The soil of sites 2, 3, and 4 classified as lean clay (CL) in the 0- to 5-in. layer and as fat clay (CH) in the 5- to 18-in. layer. The soil of site 5 classified as a fat clay (CH) in the 0- to 18-in. layer. (Classifications were in accordance with the USCS.) Soil gradation curves representative of the test sites at Carson Sink are shown in fig. 15.

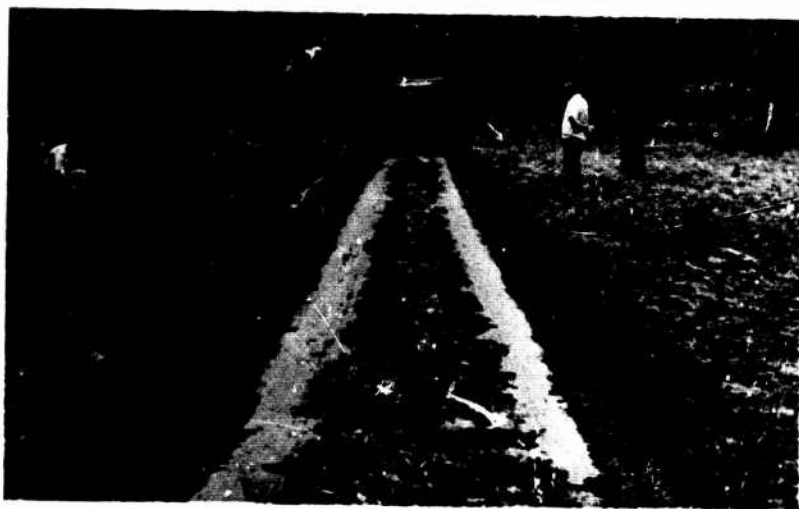
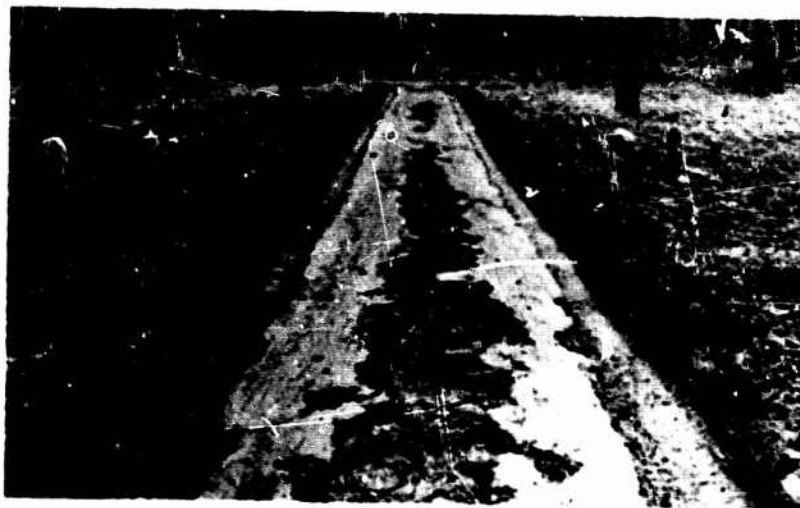
Fig. 19. VCI test in progress at Chotard Lake, XM410E1 (item 4)

a. After 1 pass

b. After 35 passes

c. After 50 passes

50 passes with ease on an RCI of 59. From these tests the experimental VCI₅₀ was placed at 56.

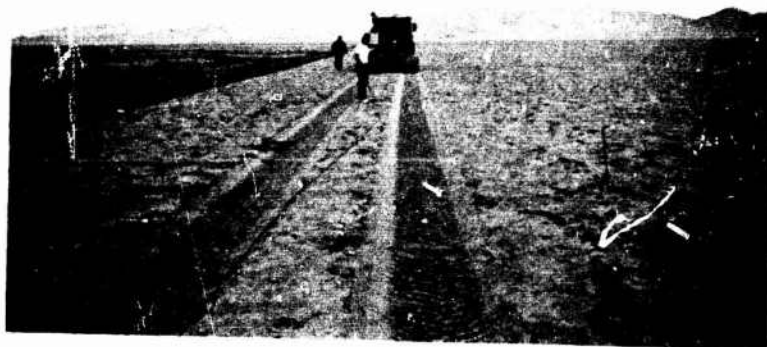
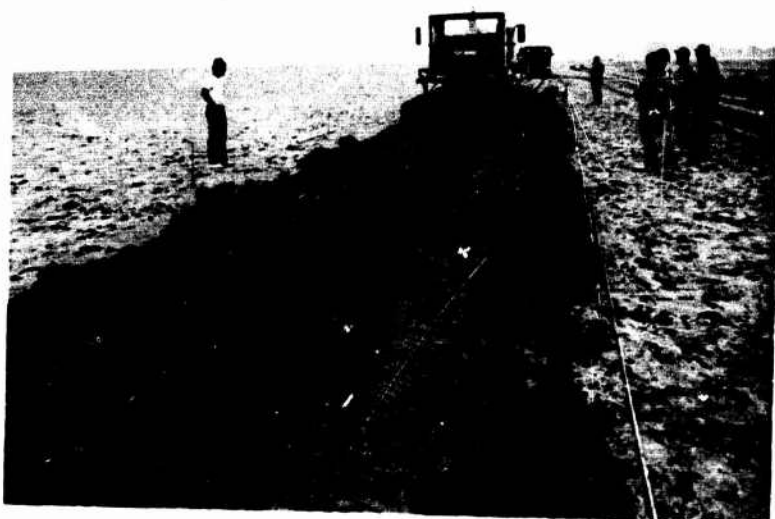
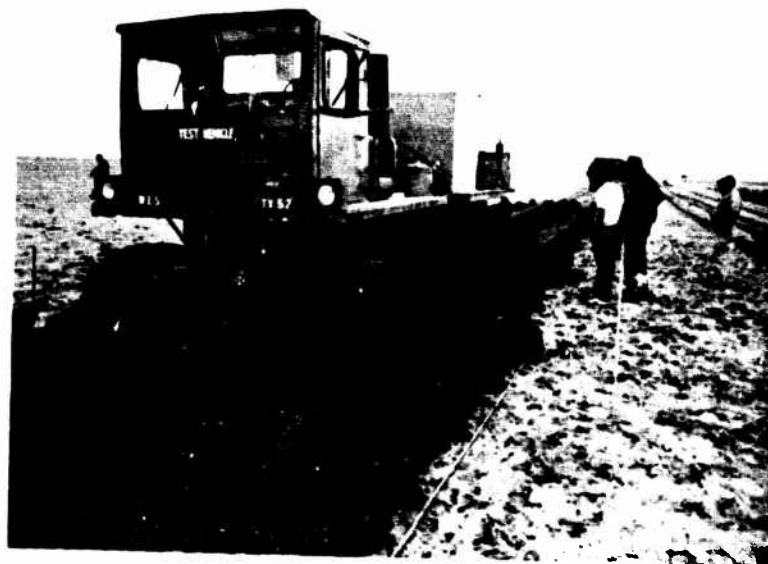
Fig. 20. VCI test in progress at Carson Sink site 3, MEXA 10x10 (item 54)

a. After 1 pass

b. After 44th pass

c. After 54th pass

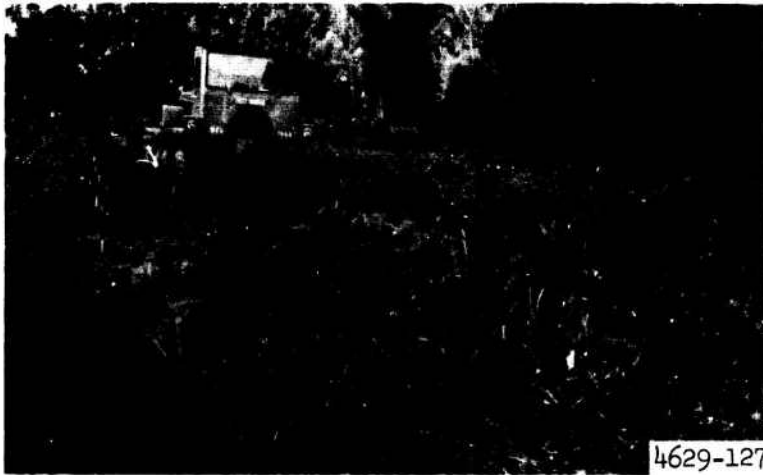
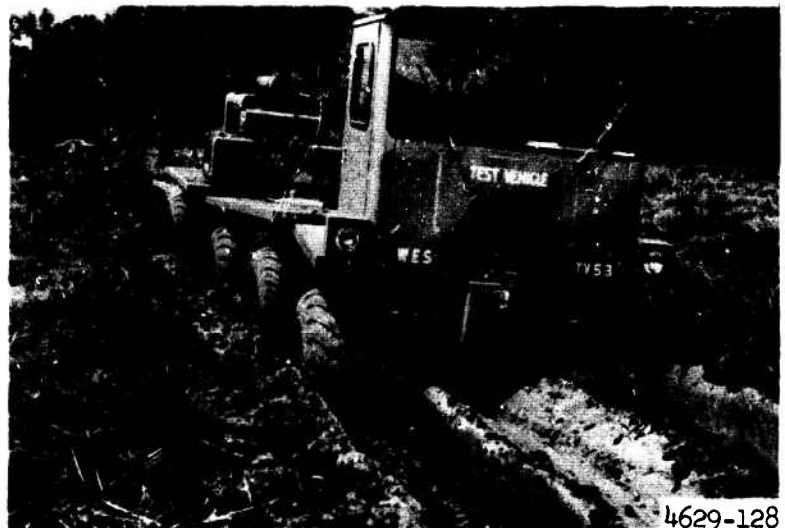
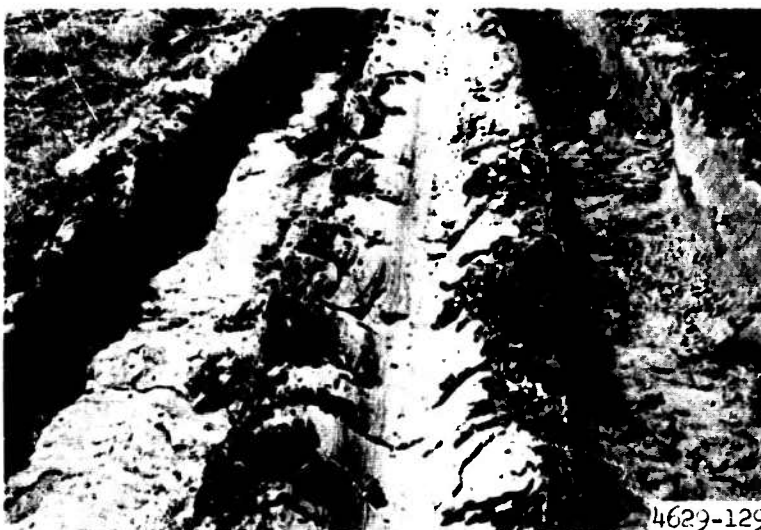
a. After 1 pass

b. On 26th pass

c. After 36 passes

34. MEXA 10x10. Eighteen VCI determination tests were conducted with the MEXA 10x10. Test results are plotted in plate 1, fig. d. In item 48 on an RCI of 15 the vehicle was considered to be immobilized on the 47th pass. In item 54 on an RCI of 19, although immobilization appeared to be imminent on the 50th pass, the test was continued through 54 passes without immobilization. Fig. 20 shows this test in progress at Carson Sink site 3. In items 50 and 53, on 22 RCI, 50 passes were completed without difficulty. From the results of these tests the experimental VCI₅₀ was placed at 18.

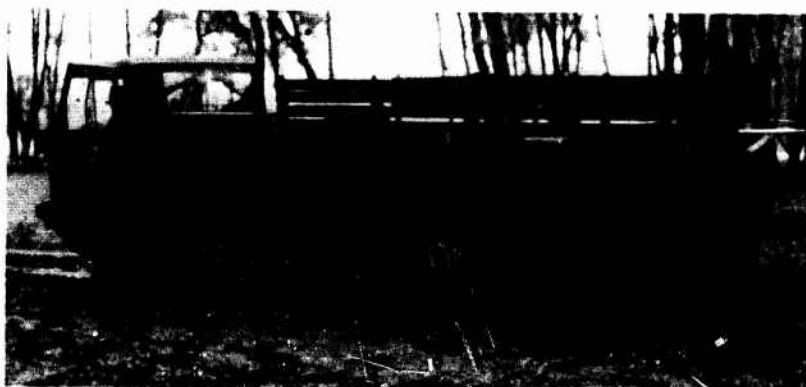
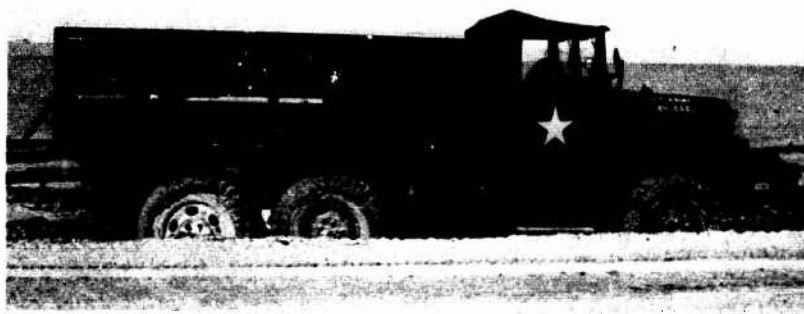
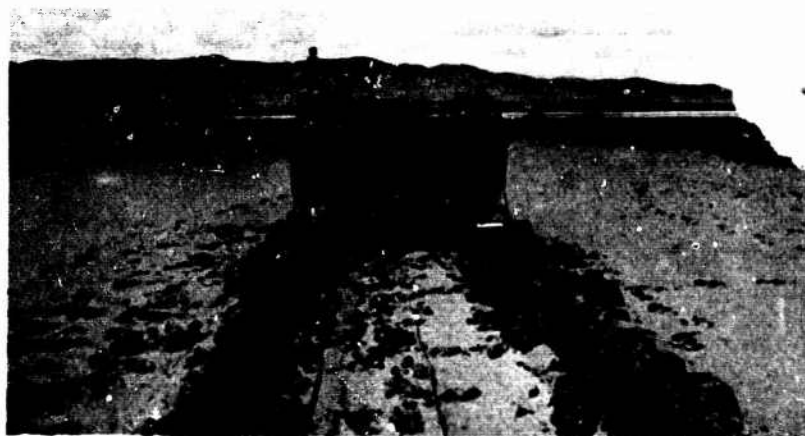
Fig. 22. Typical VCI test immobilizations, military vehicles

a. XM41OE1 was immobilized on 7th pass at Chotard Lake (item 5)

b. M35A2 (mod) was immobilized on 2d pass at Carson Sink site 2 (item 19)

c. M113 was immobilized on 1st pass at Four Mile Flat site 6 (item 41)

43. For each test, the number of passes completed versus the RCI based on this tentative critical-layer criteria was plotted by vehicle in plate 2. (Hereafter the one-pass VCI based on the tentative critical-layer criteria is designated as VCI_{1t} .) The results are discussed in the following paragraphs. Figs. 22 and 23 show typical VCI test immobilizations.

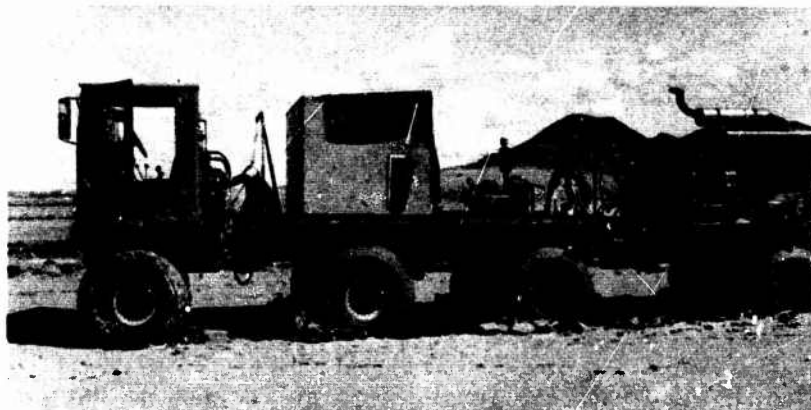
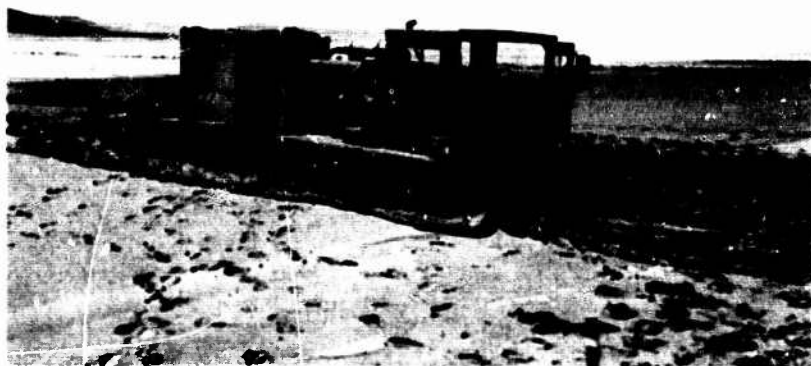
Fig. 23. Typical VCI test immobilizations, MEXA vehicles

a. MEXA 10x10 was immobilized on 1st pass at Four Mile Flat site 7 (item 55)

b. MEXA 8x8 was immobilized on 1st pass at Four Mile Flat site 6 (item 72)

c. MEXA track was immobilized on 2d pass at Four Mile Flat site 8 (item 85)

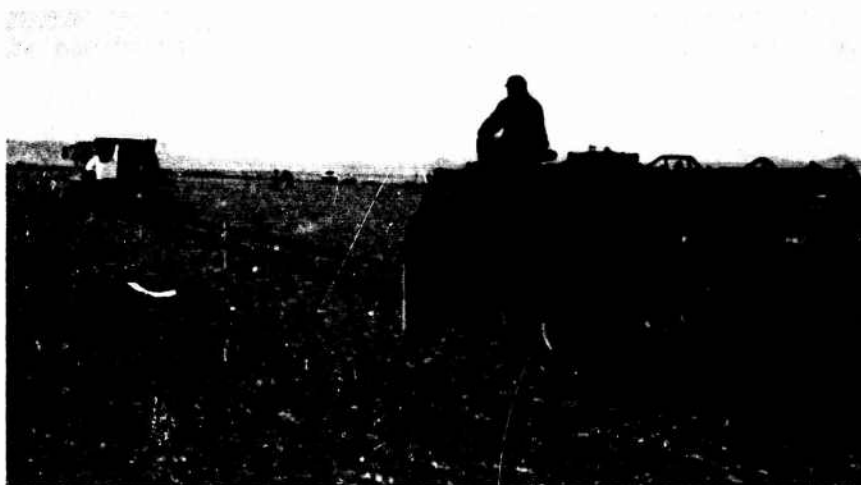
Fig. 24. MEXA track and 10x10 in position prior to start of drawbar pull tests

a. Carson Sink site 3, MEXA track (item 137)

b. Four Mile Flat site 6, MEXA 10x10 (item 119)

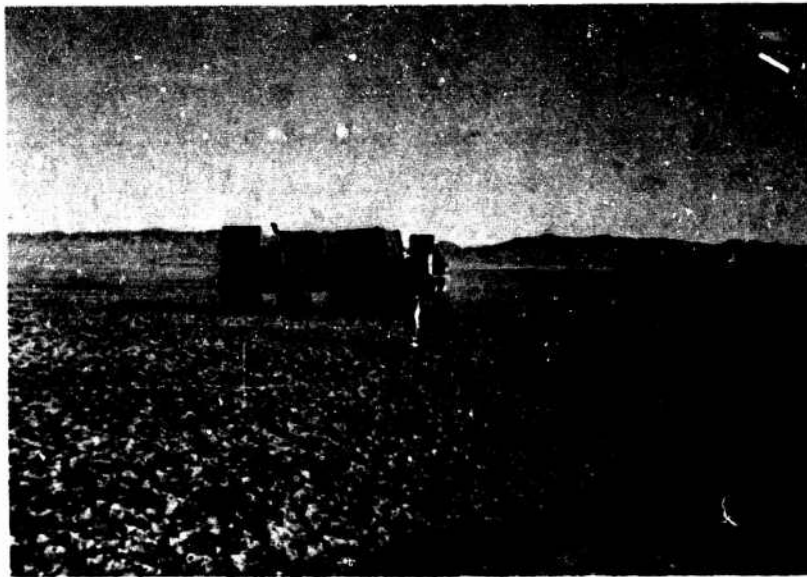
Fig. 26. Typical maneuver tests in progress

a. MEXA 10x10 after completing a left turn at Carson Sink site 4 (item 240)

b. MEXA 8x8 after completing a right turn at Four Mile Flat site 6 (item 271)

the following paragraphs. Typical maneuver tests in progress are shown in fig. 26.
